PHOTOGRAPHIC INTELLIGENCE REPORT

MILITARY FACILITIES
SSU-PING, CHINA

CIA/PIR-67175

MILITARY FACILITIES
SSU-PING, CHINA
43 10N-124 22E

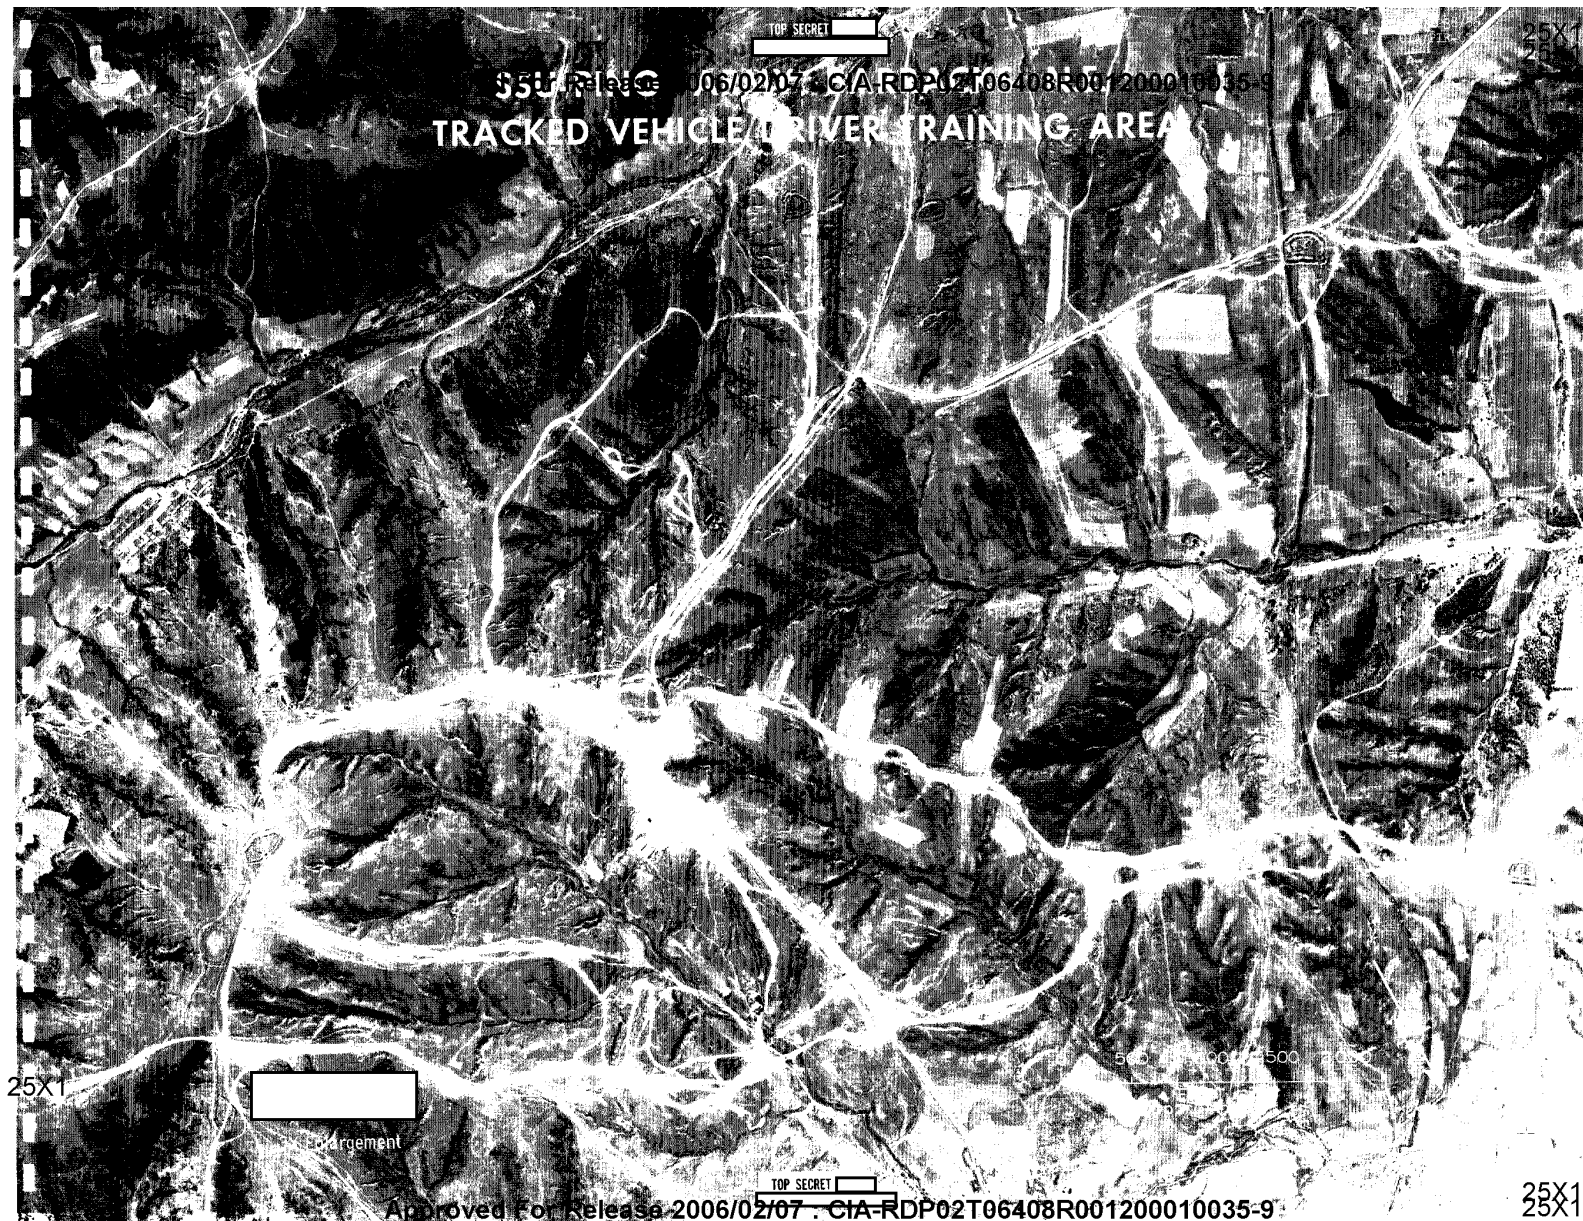
TRACKED VEHICLE DRIVER TRAINING AREA

The main tracked vehicle driver training area is located in rugged terrain 4 nm ESE of the barracks (See Figure 2 & 6). This area appears relatively active on both 1963 and 1965 photography.

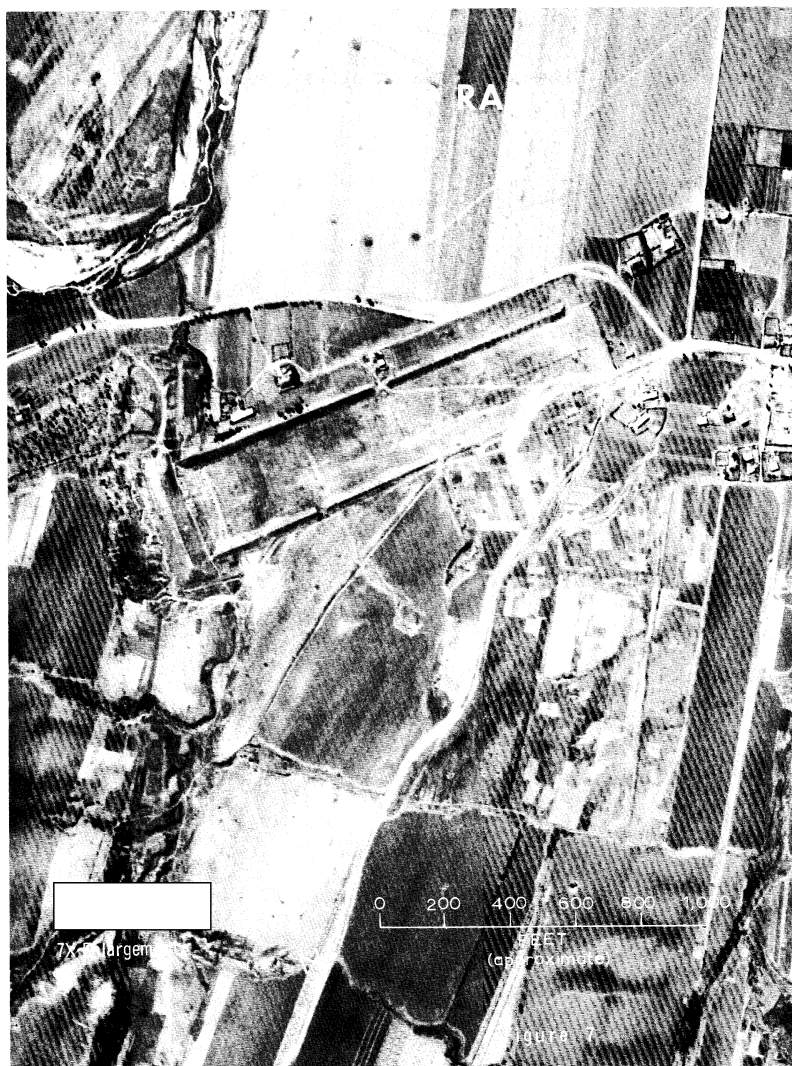
SSU-PING ARMY BARRACKS CENTRAL
43 10N-124 22EFUNCTIONAL AREAS

This area is secured by a wall with 6 gates and 5 guard posts. There are 4 vehicle maintenance racks, a concrete turning point in front of the maintenance building, and a concrete service area in front of one vehicle shed. The area was present on 1956 photography, however the concrete areas appear new.

Entire area secured by wall with 4 gates and 6 guard posts but only partially occupied. Three vehicle maintenance pits are located in front of the maintenance building. The only access from this area that appeared to be in use on [] was into area "Ha."

Track activity but no vehicles observed on [] The area is secured by a wall with 4 gates and 3 guard posts. Four vehicle maintenance pits are located within the area.

This area was previously identified as a military hospital. The large multi-wing building and the numerous trees and gardens would tend to confirm this.

Area "Ba" with its close association to "La" and similarities to area "Ba" at Ssu-Ping Army Barracks NE, such as the monitor-roofed maintenance building with vehicle maintenance pits in front, is probably used for a tank unit.

Areas "Ai," "Aj," "Ha," and "Hb" are listed as possibly associated areas because they are located within the urban complex of Ssu-Ping and have a military appearance.

Areas "Aa," "Ab," "Ad," "Ae," which appear to be mainly administrative areas and their support, were constructed between 1956 and 1962. The large barracks in the east part of area Ag were also added during this time period.
